Effect of Fault on the Physical Properties of the Ain Tabi Member: A Case Study of Al-Qwasim Mountain Road Slopes

Aboalgasem Alakhdar

Geological Engineering Department, Faculty of Engineering jadu, Nalut University, Libya.

Received: 02-05-2024 | Accepted: 10-12-2024 | Available online: 15-12-2024 | DOI:10.26629/uzjest.2024.18

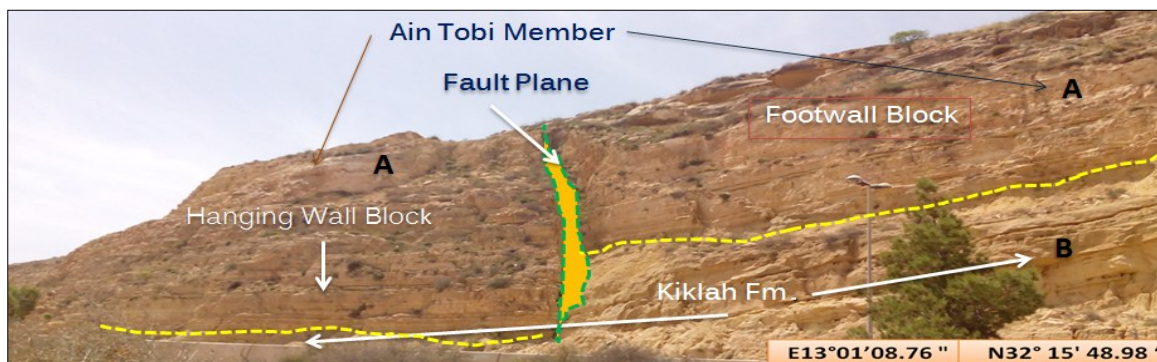
primarily composed of marly limestone, 60-80 meters thick, [12,13] with dolomite and interbeds of claystone and gypsum. The lower member, Ain Tobi Member, is 60-70 meters thick and predominantly composed of dolomitic rocks. These rocks exhibit varying crystal sizes, from fine to coarse, and colors ranging from yellow to leaden grey. Thin interbeds of marl are present. The Ain Tobi Member contains fossils indicating a Late Cretaceous age [13]. It has high rock strength, classified as Good to Very Good, due to its composition of Dolostone [14]. The rock composition contributes to increased mechanical weathering, specifically thermal weathering, and reduced chemical weathering activity [15]. According to reference [16], the fault's impact on slope stability varies depending on the nature of the affected rock layer. The fault causes stress concentration and damage to nearby rock masses, while the weak layer leads to stress concentration on the slope above, forming a hazardous sliding zone. Parallel slopes along the Tobi Mountain road have identified a normal fault Figure 3.

Figure 3: Normal fault at the study area

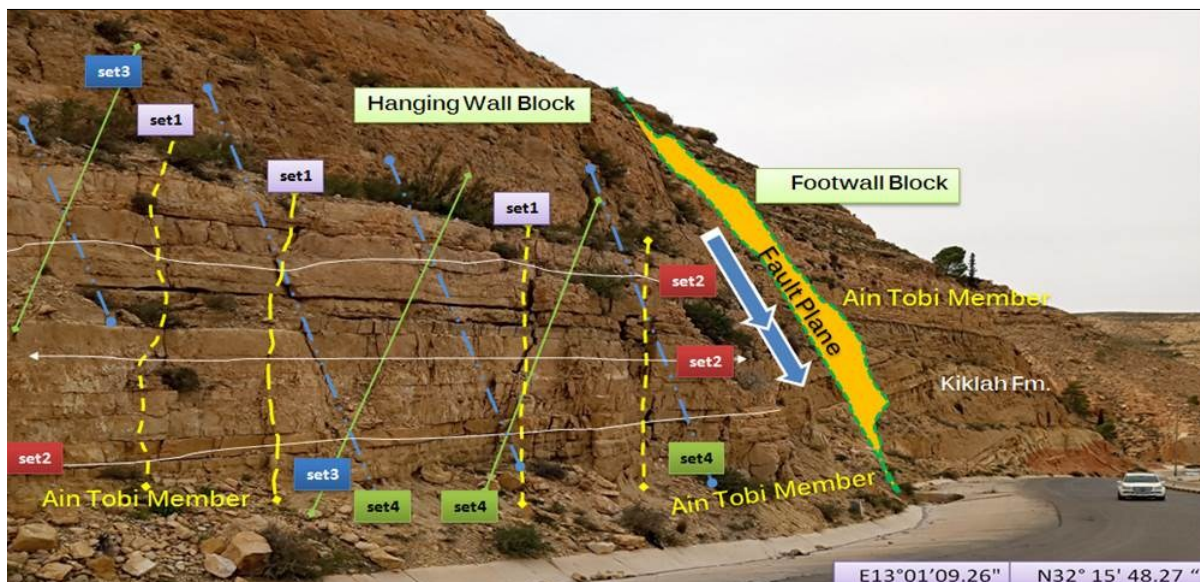
Figure 4 illustrates the presence of joint systems and the dispersion of random fractures, with a total of 450 random fractures recorded in Table 6, indicating the effect of mechanical weathering. The research confirms that the presence of these joints and fractures is attributed to the effect of the fault, which directly affected the site's rocks, in addition to considering the blasting operations as a factor weakening the slope. In Figure 4 which represents a section of the slope affected by the fault and also represents the Hanging Wall Block of the fault affected by movement, four joint systems (S1, S2, S3, S4) were observed intersecting at various angles ranging from 45° to 120°. This explains the separation of rock masses at sharp angles, with some rock masses collapsing beneath the slope. The abundance of fracture systems greatly contributed to the weakening of the slope. It is important to mention the presence of a fifth system (S5), which parallels the slope face. This system is responsible for the separation of slope rocks from the original mass, and the abundance of fracture systems also contributed to the separation of rock masses of different sizes, as shown in Figure 4. The roughness of the fracture surfaces, classified as 'Very rough' according to Table 6, played a significant role in maintaining the separated rock masses on the slope, as it increased friction.

Figure 4: slope affected by the fault (L1-R-A-23).

Based on the study of the engineering properties of Joint-Fracture, as well as the mathematical analysis in Table 6, the separation was classified as "Moderately narrow" with a value ranging from 60 to 200 mm. The joint spacing system, with a value of 45 cm indicated a generally "Widely spaced" distribution of fractures. This contributed to the overall classification and determination of the exposed rock mass strength, with a Rock Quality Designation value of 10 %. This indicates a weak condition of the rock mass. The study confirms that the observed collapses are mainly of the rock fall and toppling types,

occurring in specific locations. This is attributed to the influence of the s5 fracture system and the slope's intersecting angle, which ranges from 90° to 85° . The joint spacing system, with a value of 45 cm indicated a generally "Widely spaced" distribution of fractures. This contributed to the overall classification and determination of the exposed rock mass strength, with a Rock Quality Designation (RQD) value of 10 %. This indicates a weak condition of the rock mass. The study confirms that the observed collapses are mainly of the rock fall and toppling types.

Sectional area	200 m* height 1m = 200 m ²	Continuity	65cm
random fractures	450	Infilling materials	and Carbonate Mud
jv	31.9	Slope Angle	$^\circ 85$ - $^\circ 90$
Sa	45cm	Type of Movement	Rock fill and
1/sa	0.02	R Q D	%10
Type Rock	Dolomite - Carbonate	Joint Spacing -Js	cm45Widely spaced -
Type Roughness	Very rough	Separation	60 – 200 mm - Very narrow

The mountain road of Abu Ghaylanis one of the important roads in the Western Mountains. Its rocks were cut in 1983 to extend the road's pathway, which exposed various rocks, including dolomite rocks representing the Ain Tabi member. The slope rocks were affected by a normal fracture, causing a vertical displacement of about 7 meters. The fracture contributed to a weakened state at the site (L1-R-A-23), altering and weakening the geometric characteristics of the fissure and joint surfaces, particularly the Rock Quality Designation values. A comparison with the unaffected slope rocks (L2-R-A-23) showed higher RQD values. The study confirms that the slope is in a severely weakened state, with its rocks prone to collapse. The anticipated movement is rock falling and toppling. The study recommends the removal of the rocks at risk of collapse at the fault site, along with the placement of warning signs for passersby, especially geology students approaching the area.

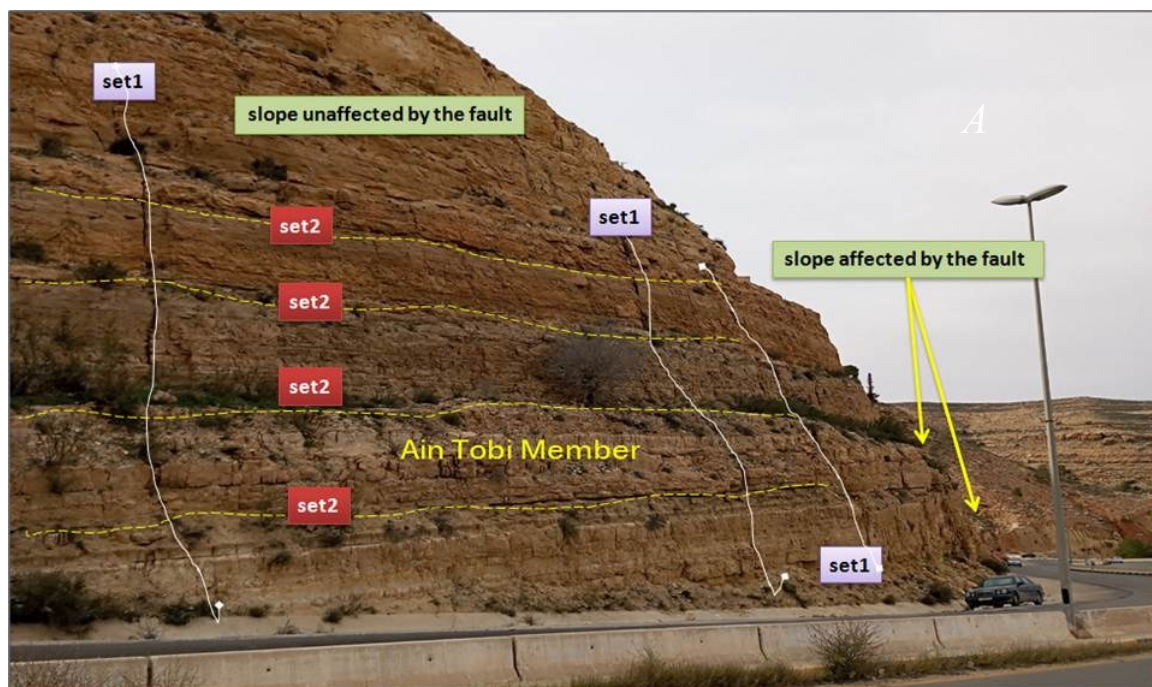
Figure 5 shows the slope unaffected by the fault. We also notice that the rocks of the slope have been cut regularly, the slope is characterized by the presence of only two joints sets intersect at an of 90° .

Figure 5: slope unaffected by the fault (L2-R-A-23)

The joint spacing between the joints and their consecutive counterparts within the same system shows significant variation, with an average overall spacing (Sa) of approximately 13.7 m along a 200 m scan line. Further observations indicate that the joint spacing values range between 2 and 6 mm, classifying them as 'Moderately narrow' according to Table 8. This suggests the stability of the slope, which is enhanced by the absence of any infill material within the joints. Moreover, the joint surfaces are characterized as 'Very rough'.

Sectional area	200 m* height 1m = 200 m ²	Continuity	20cm
Jv... 1/sa	7.27	Infilling materials	//
Sa	0.1376 cm – 13.7m	Slope Angle	°85-°90
Type Rock	Dolomite - Carbonate	Type of Movement	//
Type Roughness	Very rough	R Q D	91% Very Good
Separation	2 – 6 mm - oderately narrow	Joint Spacing (Js)	Widely spaced - 45 cm
