Effect of Fault on the Physical Properties of the Ain Tabi Member: A Case Study of Al-Qwasim Mountain Road Slopes

Aboalgasem Alakhdar

Geological Engineering Department, Faculty of Engineering jadu, Nalut University, Libya.

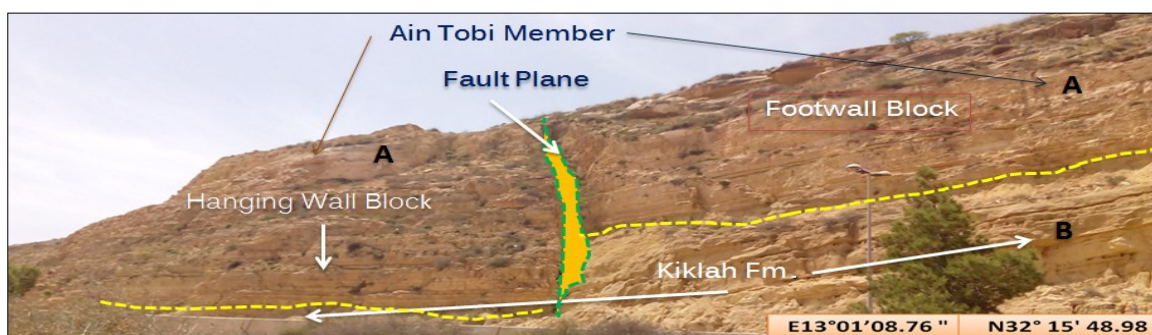
The stratigraphic sequence of the Gharyan area is illustrated in Figure 2. The SIDI AS SID Formation, affected by faults, consists of two distinct members. The upper member called the Yefren Member, is primarily composed of marly limestone, 60-80 meters thick, [12,13] with dolomite and interbeds of claystone and gypsum. The lower member, Ain Tobi Member, is 60-70 meters thick and predominantly composed of dolomitic rocks. These rocks exhibit varying crystal sizes, from fine to coarse, and colors ranging from yellow to leaden grey. Thin interbeds of marl are present. The Ain Tobi Member contains fossils indicating a Late Cretaceous age [13]. It has high rock strength, classified as Good to Very Good, due to its composition of Dolostone [14]. The rock composition contributes to increased mechanical weathering, specifically thermal weathering, and reduced chemical weathering activity [15]. According to reference [16], the fault's impact on slope stability varies depending on the nature of the affected rock layer. The fault causes stress concentration and damage to nearby rock masses, while the weak layer leads to stress concentration on the slope above, forming a hazardous sliding zone. Parallel slopes along the Tobi Mountain road have identified a normal fault Figure 3.

Figure 3: Normal fault at the study area

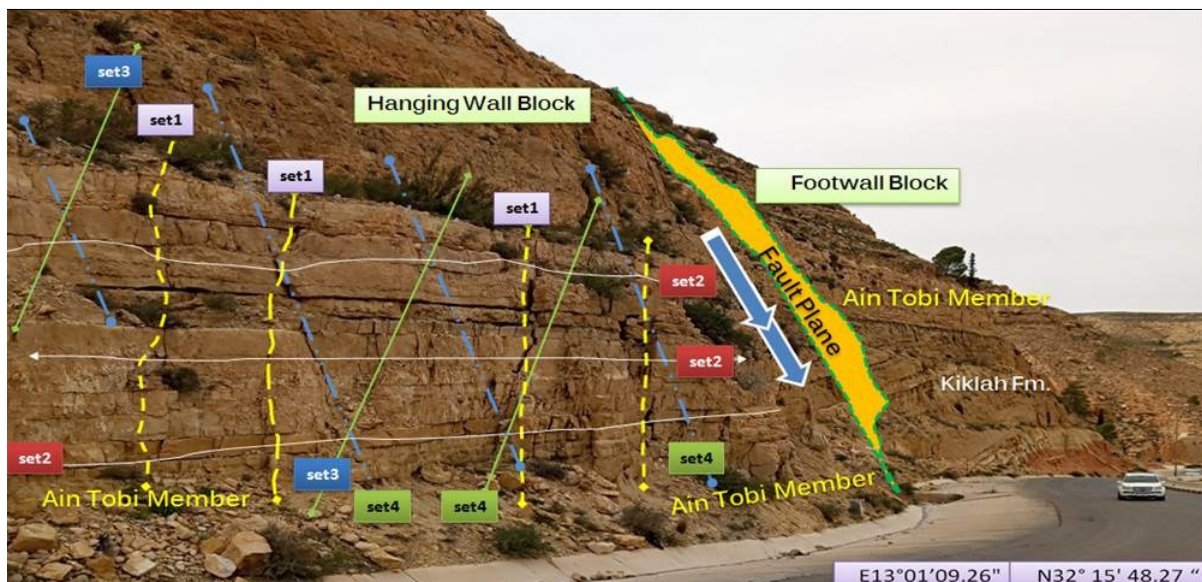
Figure 4 illustrates the presence of joint systems and the dispersion of random fractures, with a total of 450 random fractures recorded in Table 6, indicating the effect of mechanical weathering. The research confirms that the presence of these joints and fractures is attributed to the effect of the fault, which directly affected the site's rocks, in addition to considering the blasting operations as a factor weakening the slope. In Figure 4 which represents a section of the slope affected by the fault and also represents the Hanging Wall Block of the fault affected by movement, four joint systems (S1, S2, S3, S4) were observed intersecting at various angles ranging from 45° to 120°. This explains the separation of rock masses at sharp angles, with some rock masses collapsing beneath the slope. The abundance of fracture systems greatly contributed to the weakening of the slope. It is important to mention the presence of a fifth system (S5), which parallels the slope face. This system is responsible for the separation of slope rocks from the original mass, and the abundance of fracture systems also contributed to the separation of rock masses of different sizes, as shown in Figure 4. The roughness of the fracture surfaces, classified as 'Very rough' according to Table 6, played a significant role in maintaining the separated rock masses on the slope, as it increased friction.

Figure 4: slope affected by the fault (L1-R-A-23).

Based on the study of the engineering properties of Joint-Fracture, as well as the mathematical analysis in Table 6, the separation was classified as "Moderately narrow" with a value ranging from 60 to 200 mm. The joint spacing system, with a value of 45 cm indicated a generally "Widely spaced" distribution of fractures. This contributed to the overall classification and determination of the exposed rock mass strength, with a Rock Quality Designation value of 10 %. This indicates a weak condition of the rock mass. The study confirms that the observed collapses are mainly of the rock fall and toppling types,

occurring in specific locations. This is attributed to the influence of the s5 fracture system and the slope's intersecting angle, which ranges from 90° to 85°. The joint spacing system, with a value of 45 cm indicated a generally "Widely spaced" distribution of fractures. This contributed to the overall classification and determination of the exposed rock mass strength, with a Rock Quality Designation (RQD) value of 10 %. This indicates a weak condition of the rock mass. The study confirms that the observed collapses are mainly of the rock fall and toppling types.

The mountain road of Abu Ghaylanis one of the important roads in the Western Mountains. Its rocks were cut in 1983 to extend the road's pathway, which exposed various rocks, including dolomite rocks representing the Ain Tabi member. The slope rocks were affected by a normal fracture, causing a vertical displacement of about 7 meters. The fracture contributed to a weakened state at the site (L1-R-A-23), altering and weakening the geometric characteristics of the fissure and joint surfaces, particularly the Rock Quality Designation values. A comparison with the unaffected slope rocks (L2-R-A-23) showed higher RQD values. The study confirms that the slope is in a severely weakened state, with its rocks prone to collapse. The anticipated movement is rock falling and toppling. The study recommends the removal of the rocks at risk of collapse at the fault site, along with the placement of warning signs for passersby, especially geology students approaching the area.
