# Effect of Fault on the Physical Properties of the Ain Tabi Member: A Case Study of Al-Qwasim Mountain Road Slopes

Aboalgasem Alakhdar

Geological Engineering Department, Faculty of Engineering jadu, Nalut University, Libya.

Received: 02-05-2024 | Accepted: 10-12-2024 | Available online: 15-12-2024 | DOI:10.26629/uzjest.2024.18

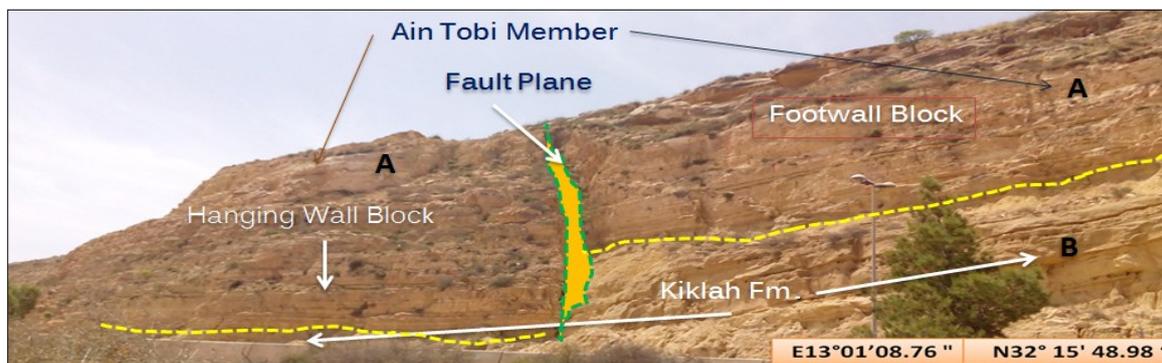
primarily composed of marly limestone, 60-80 meters thick, [12,13] with dolomite and interbeds of claystone and gypsum. The lower member, Ain Tobi Member, is 60-70 meters thick and predominantly composed of dolomitic rocks. These rocks exhibit varying crystal sizes, from fine to coarse, and colors ranging from yellow to leaden grey. Thin interbeds of marl are present. The Ain Tobi Member contains fossils indicating a Late Cretaceous age [13]. It has high rock strength, classified as Good to Very Good, due to its composition of Dolostone [14]. The rock composition contributes to increased mechanical weathering, specifically thermal weathering, and reduced chemical weathering activity [15]. According to reference [16], the fault's impact on slope stability varies depending on the nature of the affected rock layer. The fault causes stress concentration and damage to nearby rock masses, while the weak layer leads to stress concentration on the slope above, forming a hazardous sliding zone. Parallel slopes along the Tobi Mountain road have identified a normal fault Figure 3.

Figure 3: Normal fault at the study area

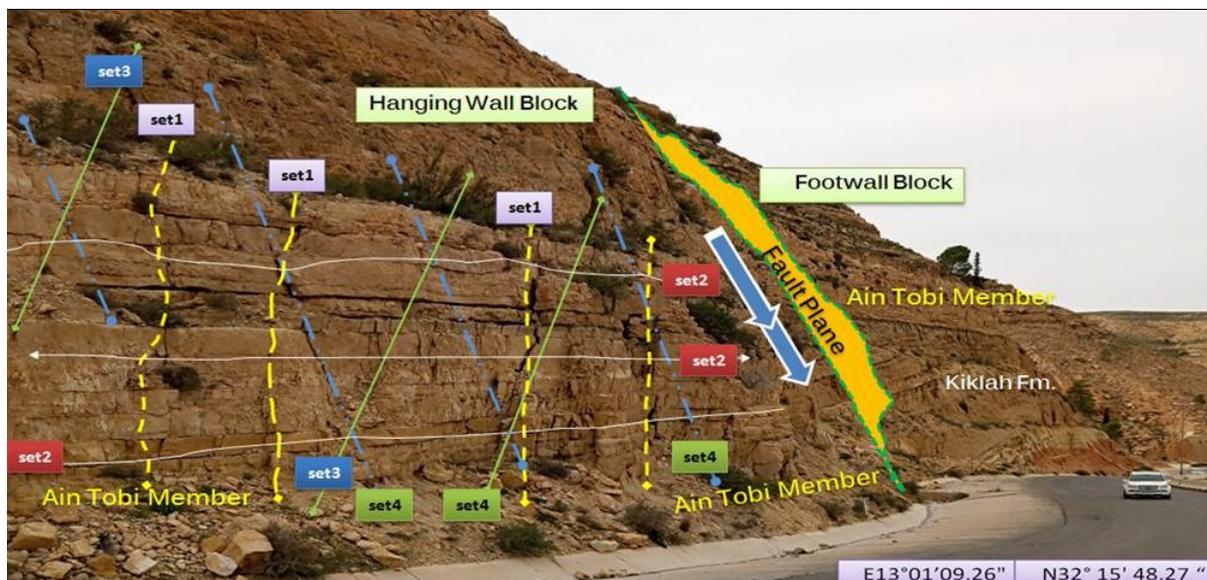
Figure 4 illustrates the presence of joint systems and the dispersion of random fractures, with a total of 450 random fractures recorded in Table 6, indicating the effect of mechanical weathering. The research confirms that the presence of these joints and fractures is attributed to the effect of the fault, which directly affected the site's rocks, in addition to considering the blasting operations as a factor weakening the slope. In Figure 4 which represents a section of the slope affected by the fault and also represents the Hanging Wall Block of the fault affected by movement, four joint systems (S1, S2, S3, S4) were observed intersecting at various angles ranging from 45° to 120°. This explains the separation of rock masses at sharp angles, with some rock masses collapsing beneath the slope. The abundance of fracture systems greatly contributed to the weakening of the slope. It is important to mention the presence of a fifth system (S5), which parallels the slope face. This system is responsible for the separation of slope rocks from the original mass, and the abundance of fracture systems also contributed to the separation of rock masses of different sizes, as shown in Figure 4. The roughness of the fracture surfaces, classified as 'Very rough' according to Table 6, played a significant role in maintaining the separated rock masses on the slope, as it increased friction.

Figure 4: slope affected by the fault (L1-R-A-23).

Based on the study of the engineering properties of Joint-Fracture, as well as the mathematical analysis in Table 6, the separation was classified as "Moderately narrow" with a value ranging from 60 to 200 mm. The joint spacing system, with a value of 45 cm indicated a generally "Widely spaced" distribution of fractures. This contributed to the overall classification and determination of the exposed rock mass strength, with a Rock Quality Designation value of 10 %. This indicates a weak condition of the rock mass. The study confirms that the observed collapses are mainly of the rock fall and toppling types,

occurring in specific locations. This is attributed to the influence of the s5 fracture system and the slope's intersecting angle, which ranges from 90° to 85°. The joint spacing system, with a value of 45 cm indicated a generally "Widely spaced" distribution of fractures. This contributed to the overall classification and determination of the exposed rock mass strength, with a Rock Quality Designation (RQD) value of 10 %. This indicates a weak condition of the rock mass. The study confirms that the observed collapses are mainly of the rock fall and toppling types.

The mountain road of Abu Ghaylanis one of the important roads in the Western Mountains. Its rocks were cut in 1983 to extend the road's pathway, which exposed various rocks, including dolomite rocks representing the Ain Tabi member. The slope rocks were affected by a normal fracture, causing a vertical displacement of about 7 meters. The fracture contributed to a weakened state at the site (L1-R-A-23), altering and weakening the geometric characteristics of the fissure and joint surfaces, particularly the Rock Quality Designation values. A comparison with the unaffected slope rocks (L2-R-A-23) showed higher RQD values. The study confirms that the slope is in a severely weakened state, with its rocks prone to collapse. The anticipated movement is rock falling and toppling. The study recommends the removal of the rocks at risk of collapse at the fault site, along with the placement of warning signs for passersby, especially geology students approaching the area.

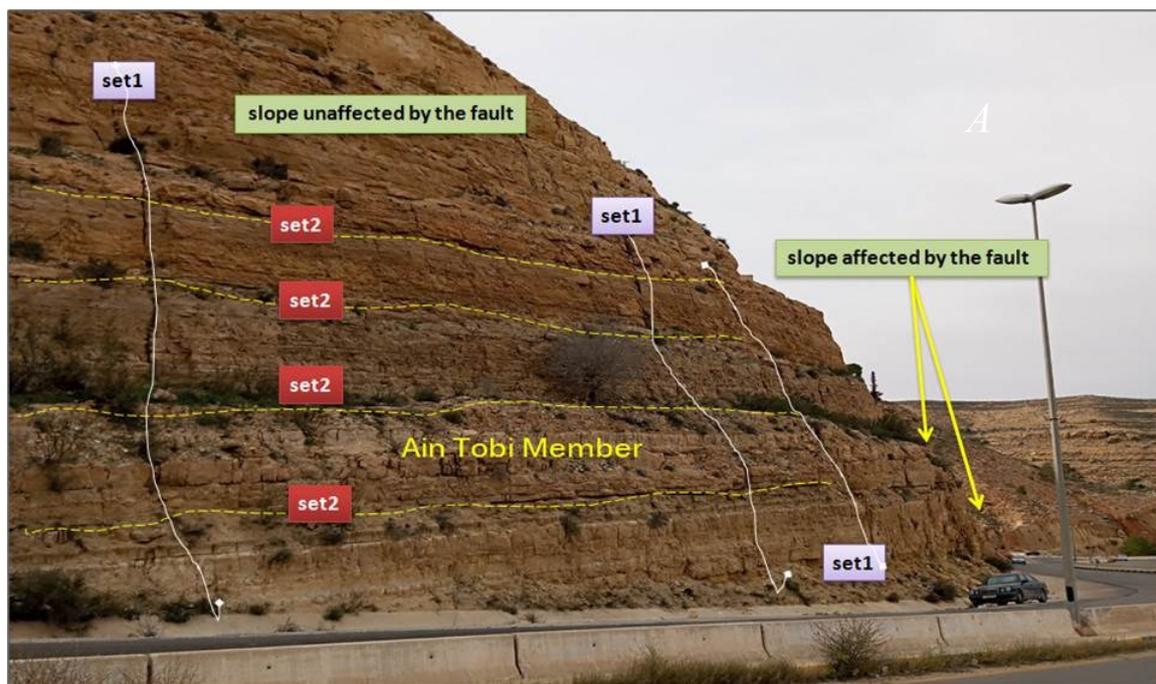
Figure 5 shows the slope unaffected by the fault. We also notice that the rocks of the slope have been cut regularly, the slope is characterized by the presence of only two joints sets intersect at an of 90°.

Figure 5: slope unaffected by the fault ( L2-R-A-23)

The joint spacing between the joints and their consecutive counterparts within the same system shows significant variation, with an average overall spacing (Sa) of approximately 13.7 m along a 200 m scan line. Further observations indicate that the joint spacing values range between 2 and 6 mm, classifying them as 'Moderately narrow' according to Table 8. This suggests the stability of the slope, which is enhanced by the absence of any infill material within the joints. Moreover, the joint surfaces are characterized as 'Very rough'.
